**Flood Control Project Maintenance
Levee Inspections**

Maintenance Issue Types Only, Levee Inspection Report By Mile - Spring 2016

Reclamation District No. 0556 Upper Andrus

Waterway	Bank	Unit Miles	Inspection Start/End	Inspector
Unit No. 01 Georgiana Slough	Right	5.48	03/09/2016 03/09/2016	Herman Phillips

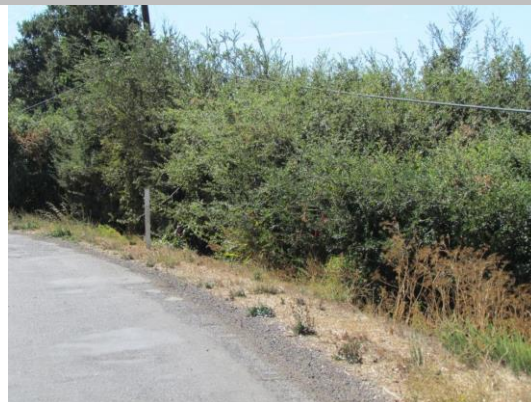
Photo 1 of 1 : SP_2016_RD0556_18_10_20160223_00003.jpg

LM Start	0.93	Rating **	U	Issue No.	10
LM End	1.54	Issue Type +	Ma	Location *	LS
Category	Earthen Levee			GPS Latitude/Longitude	
				Start	End
Item	Trim / Thin Trees			38.228295 °	38.225368 °
				-121.526688 °	-121.534677 °
DWR ID	DWR_RD0556_01_f_2015_10				
Comment Code					
T1 : Trim trees to at least five feet above ground level.					
Inspector Comment					
Remove the woody tree growth from the landside levee section.

Unsatisfactory woody tree growth on the landside shoulder and slope.

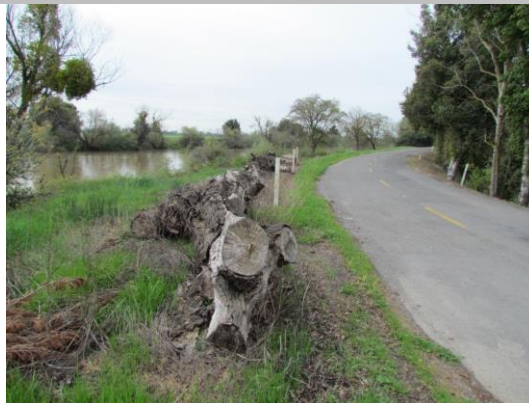
Photo 1 of 1 : SP_2016_RD0556_18_9_20160512_00056.jpg

LM Start	1.55	Rating **	U	Issue No.	9
LM End	1.57	Issue Type +	Ma	Location *	WS
Category	Earthen Levee			GPS Latitude/Longitude	
				Start	End
Item	Encroachments			38.225191 °	38.224976 °
				-121.534799 °	-121.535043 °
DWR ID	DWR_RD0556_01_s_2012_9				
Comment Code					
TR : Tree or limb					
Inspector Comment					
These cut up tree sections remain on the waterward slope. The owner is on the Reclamation District's Board, Mr. Silva said he will ask him to remove the encroachment.

Looking downstream of the waterside shoulder levee mile 1.55-1.57 unauthorized encroachment of cut up sections of dead tree.

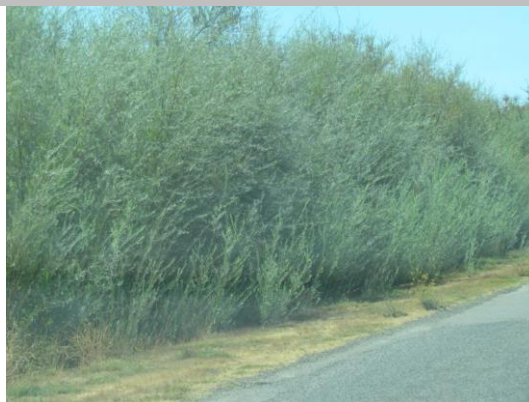
Photo 1 of 1 : SP_2016_RD0556_18_74_20160223_00014.jpg

LM Start	1.74	Rating **	U	Issue No.	74
LM End	2.25	Issue Type +	Ma	Location *	WS
Category	Earthen Levee			GPS Latitude/Longitude	
				Start	End
Item	Vegetation			38.224198 °	38.220853 °
				-121.537987 °	-121.544360 °
DWR ID	DWR_RD0556_01_f_2015_74				
Comment Code					
V7 : Trees / Woody Vegetation					
Inspector Comment					
This arundo needs to be removed, this vegetation blocks the view of the waterside slope.

Levee mile 1.74-2.00 waterside wild growth of arundo present on levee shoulder and slope, unable to see the ground.

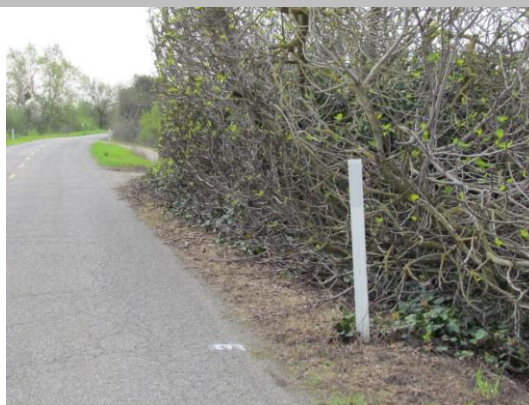
Photo 1 of 1 : SP_2016_RD0556_18_24_20160512_00058.jpg

LM Start	2.32	Rating **	U	Issue No.	24
LM End	2.34	Issue Type +	Ma	Location *	LS
Category	Earthen Levee			GPS Latitude/Longitude	
				Start	End
Item	Vegetation			38.219822 °	38.219592 °
				-121.544000 °	-121.543927 °
DWR ID	DWR_RD0556_01_s_2012_24				
Comment Code					
V7 : Trees / Woody Vegetation					
Inspector Comment					
Unable to see the levee section for heavy growth of trees. Remove them or thin them out so the slope can be seen.

Looking downstream from levee mile 2.32- 2.34 woody growth of fig trees blocking the view of the levee slope and toe.

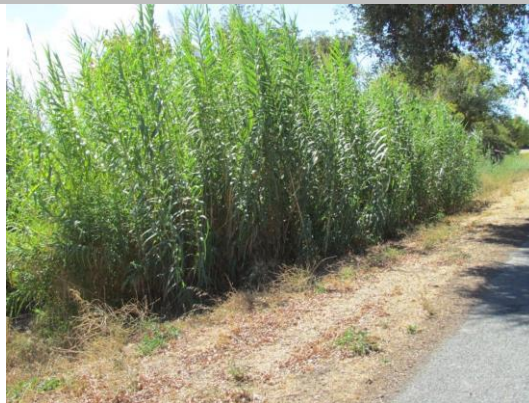
Photo 1 of 1 : SP_2016_RD0556_18_78_20160223_00015.jpg

LM Start	3.12	Rating **	U	Issue No.	78
LM End	3.15	Issue Type +	Ma	Location *	WS
Category	Earthen Levee			GPS Latitude/Longitude	
				Start	End
Item	Vegetation			38.211090 °	38.210927 °
				-121.537983 °	-121.538473 °
DWR ID	DWR_RD0556_01_f_2015_78				
Comment Code					
V1 : Control annual grass and weeds on the levee slopes and easements.					
Inspector Comment					
Remove the arundo from the levee slope waterside.

Looking downstream from waterside shoulder, arundo blocking view of levee section.

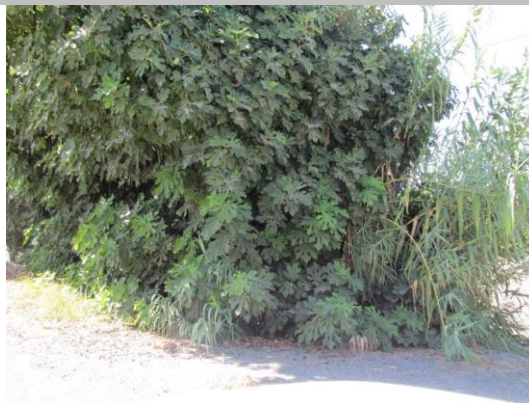
Photo 1 of 1 : SP_2016_RD0556_18_79_20160223_00016.jpg

LM Start	3.17	Rating **	U	Issue No.	79
LM End	3.28	Issue Type +	Ma	Location *	LS
Category	Earthen Levee			GPS Latitude/Longitude	
				Start	End
Item	Vegetation			38.210823 °	38.209983 °
				-121.538813 °	-121.540533 °
DWR ID	DWR_RD0556_01_f_2015_79				
Comment Code					
V2 : Remove the wild growth other than native grasses from the levee slopes.					
Inspector Comment					
Remove the unsatisfactory growth of vegetation from the levee section.

Unsatisfactory woody tree growth and arundo blocking view of landside levee shoulder and slope.

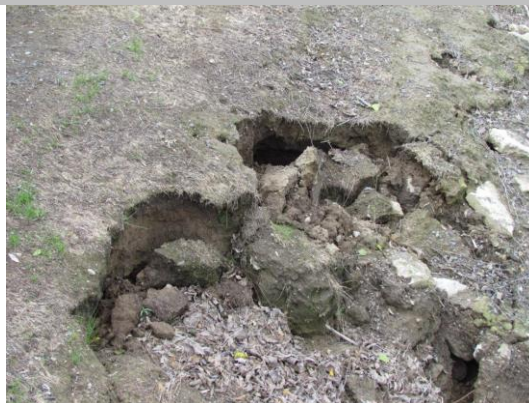
Photo 1 of 1 : SP_2016_RD0556_18_46_20160512_00065.jpg

LM Start	3.24	Rating **	U	Issue No.	46
LM End	3.24	Issue Type +	Ma	Location *	LS
Category	Earthen Levee			GPS Latitude/Longitude	
				Start	End
Item	Erosion / Bank Caving			38.210353 °	38.210353 °
				-121.539998 °	-121.539998 °
DWR ID	DWR_RD0556_01_s_2016_46				
Comment Code					
E2 : Schedule repair of erosion site prior to the next inspection.					
Inspector Comment					
Repairs needed at this site before rainy season.

Looking from levee mile 3.24 landside slope. Erosion has occurred from gopher holes in slope.

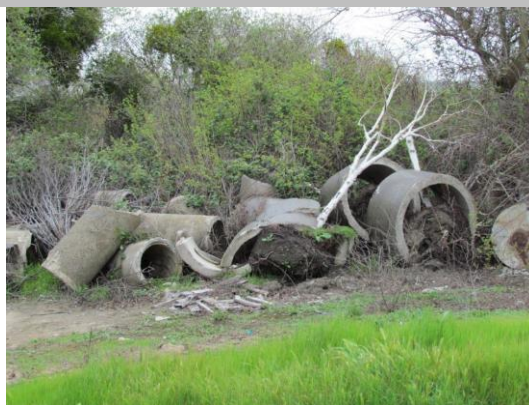
Photo 1 of 1 : SP_2016_RD0556_18_23_20160512_00062.jpg

LM Start	3.46	Rating **	U	Issue No.	23
LM End	3.46	Issue Type +	Ma	Location *	WS
Category	Earthen Levee			GPS Latitude/Longitude	
				Start	End
Item	Encroachments			38.207585 °	38.207585 °
				-121.541655 °	-121.541655 °
DWR ID	DWR_RD0556_01_f_2015_23				
Comment Code					
DE : Debris					
Inspector Comment					
Remove discarded concrete pipe and plant containers from the levee section.

Looking downstream of levee mile 3.46 discarded concrete pipe and plant containers on the waterside shoulder.

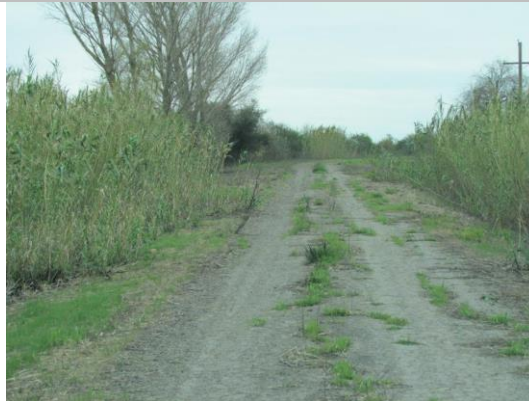
Photo 1 of 1 : SP_2016_RD0556_18_51_20160512_00063.jpg

LM Start	3.74	Rating **	U	Issue No.	51
LM End	5.47	Issue Type +	Ma	Location *	WS
Category	Earthen Levee			GPS Latitude/Longitude	
				Start	End
Item	Vegetation			38.203577 °	38.186492 °
				-121.541025 °	-121.562487 °
DWR ID	DWR_RD0556_01_s_2016_51				
Comment Code					
V2 : Remove the wild growth other than native grasses from the levee slopes.					
Inspector Comment					
Remove the arundo from the waterside shoulder and slope from 3.74-5.47.

Levee mile 3.74 - 5.47 arundo has taken over the waterside slope and shoulder.

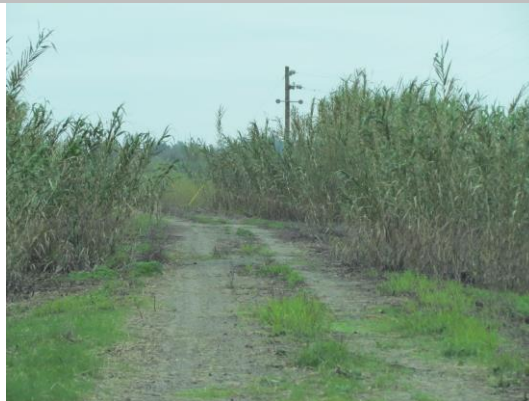
Photo 1 of 1 : SP_2016_RD0556_18_66_20160512_00064.jpg

LM Start	4.07	Rating **	U	Issue No.	66
LM End	5.47	Issue Type +	Ma	Location *	LS
Category	Earthen Levee			GPS Latitude/Longitude	
				Start	End
Item	Vegetation			38.200659 °	38.186542 °
				-121.544711 °	-121.562411 °
DWR ID	DWR_RD0556_01_s_2013_66				
Comment Code					
V2 : Remove the wild growth other than native grasses from the levee slopes.					
Inspector Comment					
Remove the wild vegetation and arundo from the landside shoulder and slope.

Looking downstream from the landside shoulder and slope levee mile 4.07-5.47 arundo completely blocking the view of the levee section.

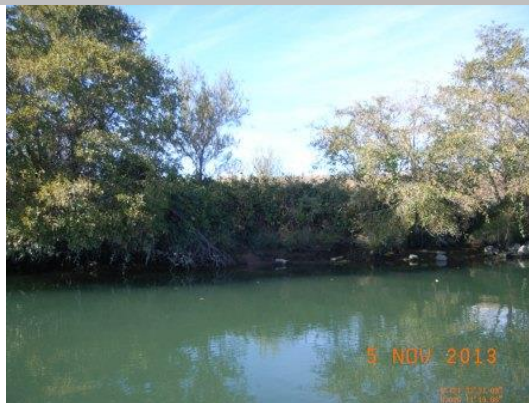
Photo 1 of 1 : SP_2016_RD0556_18_1_20160223_00001.jpg

LM Start	5.12	Rating **	M	Issue No.	1
LM End	5.27	Issue Type +	Ma	Location *	WS
Category	Supplemental			GPS Latitude/Longitude	
				Start	End
Item	2015 USACE Erosion Survey, DRAFT			38.189775 °	38.188121 °
				-121.557729 °	-121.559413 °
DWR ID	DWR_RD0556_01_s_2016_1				
Comment Code					
Inspector Comment					
1997 - Toe damaged rock. 1999 - One pocket filled with gravel. 2000 - Eroding beach with some biotech rolls and stakes; some gravel on slope. 2001 - Staked, low fascine walls at bankline. 2005 - Stone revetment in between pockets. 2006 - New rock on upper slope behind brush boxes at the upstream end, Stone is sliding off the hard toe. 2015: Last observed in 2013. [2015 Site ID: GEO_7-0_R]

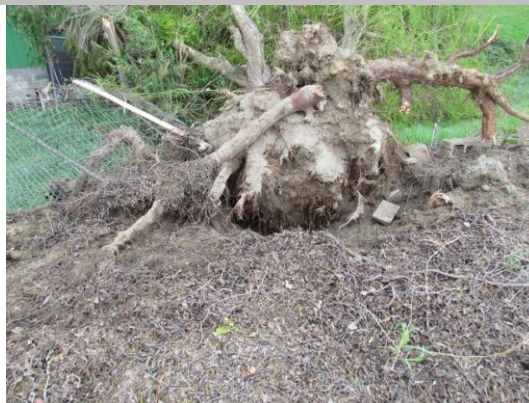
Photo 1 of 2 : SP_2016_RD0556_18_54_20160512_00059.jpg

LM Start	5.45	Rating **	U	Issue No.	54
LM End	5.45	Issue Type +	Ma	Location *	LS
Category	Earthen Levee			GPS Latitude/Longitude	
				Start	End
Item	Erosion / Bank Caving			38.186587 °	38.186587 °
				-121.562143 °	-121.562143 °
DWR ID	DWR_RD0556_01_s_2016_54				
Comment Code					
E2 : Schedule repair of erosion site prior to the next inspection.					
Inspector Comment					
Tree blown down storm damage land side. EROSION DAMAGE TO SLOPE AND SHOLDER.

Standing at levee mile 5.45 landside fallen tree blown over by storm. Erosion has occurred at location. Looking upstream.

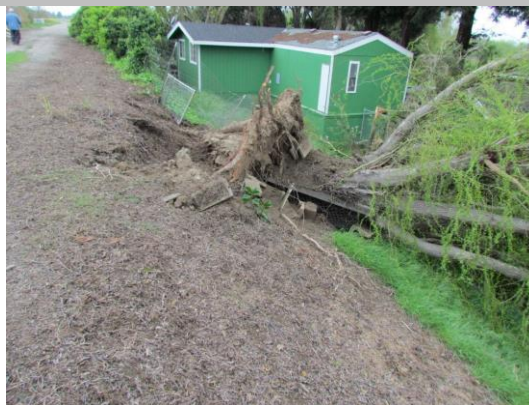
Photo 2 of 2 : SP_2016_RD0556_18_54_20160512_00061.jpg

Standing at levee mile 5.45 looking downstream at fallen tree and bank erosion.

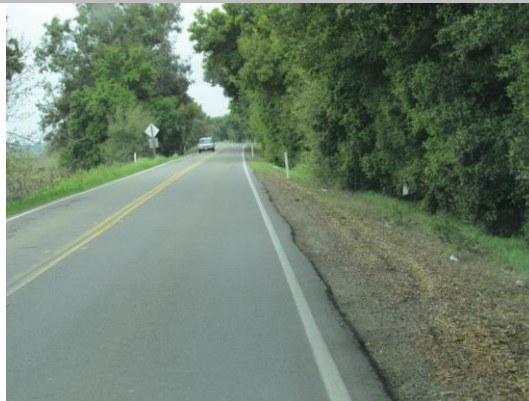
Photo 1 of 1 : SP_2016_RD0556_19_82_20160512_00056.jpg

RD 556 Unit 2 levee mile 0.00 looking at the water side levee slope.

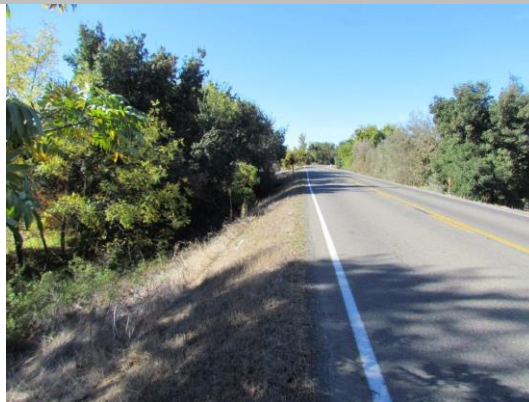
Photo 1 of 1 : SP_2016_RD0556_19_66_20160223_00012.jpg

LM Start	0.57	Rating **	U	Issue No.	66
LM End	1.35	Issue Type +	Ma	Location *	LS
Category	Earthen Levee			GPS Latitude/Longitude	
				Start	End
Item	Vegetation			38.237752 °	38.239821 °
				-121.528593 °	-121.542440 °
DWR ID	DWR_RD0556_02_f _ 2015_66				
Comment Code					
V7 : Trees / Woody Vegetation					
Inspector Comment					
Remove the wild growth and trim the trees off the levee slope.

Looking downstream from the landside levee slope levee mile ,0.57.

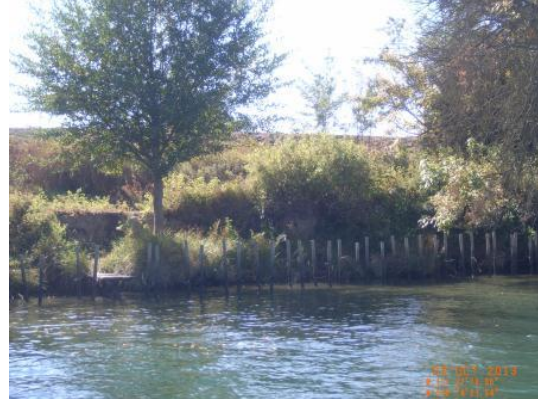
Photo 1 of 1 : SP_2016_RD0556_19_2_20160223_00002.jpg

LM Start	1.03	Rating **	M	Issue No.	2
LM End	1.15	Issue Type +	Ma	Location *	WS
Category	Supplemental			GPS Latitude/Longitude	
				Start	End
Item	2015 USACE Erosion Survey, DRAFT			38.238772 °	38.239265 °
				-121.536788 °	-121.538845 °
DWR ID	DWR_RD0556_02_s _ 2016_2				
Comment Code					
Inspector Comment					
1997 - Rock is in poor condition and has failed in many places. Scallops in berm with remnants of old rock in the toe area. 2005 - Brush boxes present. 2013 - Site extended upstream approximately 300 ft to include new erosion pockets. 2015: Minor new erosion at toe. [2015 Site ID: SAC_25-2_L]

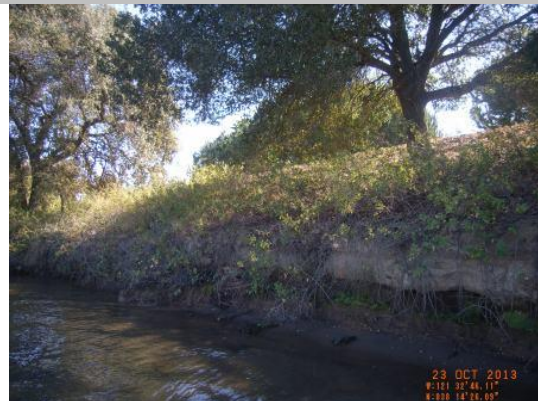
Photo 1 of 1 : SP_2016_RD0556_19_5_20160223_00005.jpg

LM Start	1.45	Rating **	M	Issue No.	5
LM End	1.59	Issue Type +	Ma	Location *	WS
Category	Supplemental			GPS Latitude/Longitude	
				Start	End
Item	2015 USACE Erosion Survey, DRAFT			38.240401 °	38.240772 °
				-121.544106 °	-121.546791 °
DWR ID	DWR_RD0556_02_s _ 2016_5				
Comment Code					
Inspector Comment					
1997 - Slow erosion of the berm at the waterline; bench below water. 2005 - Brush boxes present. 2010 - Minor new erosion. 2013 - There is little to no berm remaining at downstream end of this site. 2015: No observed changes. [2015 Site ID: SAC_24-8_L]

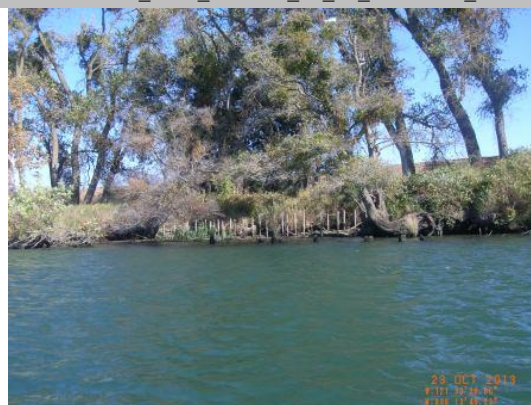
Photo 1 of 1 : SP_2016_RD0556_19_11_20160223_00009.jpg

LM Start	2.93	Rating **	M	Issue No.	11
LM End	3.04	Issue Type +	Ma	Location *	WS
Category	Supplemental			GPS Latitude/Longitude	
				Start	End
Item	2015 USACE Erosion Survey, DRAFT			38.228202 °	38.226601 °
				-121.555502 °	-121.555605 °
DWR ID	DWR_RD0556_02_s_2016_11				
Comment Code					
Inspector Comment					
1997 - Few scallops in berm, some getting close to levee toe. 2005 - Brush boxes present. 2012 - More erosion of the toe since last year. 2015: No observed changes. [2015 Site ID: SAC_23-3_L]

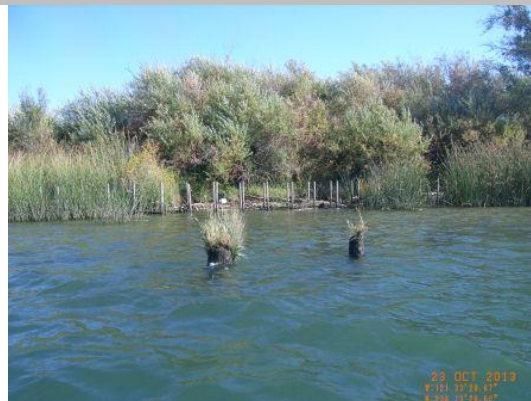
Photo 1 of 1 : SP_2016_RD0556_19_10_20160223_00008.jpg

LM Start	3.17	Rating **	M	Issue No.	10
LM End	3.28	Issue Type +	Ma	Location *	WS
Category	Supplemental			GPS Latitude/Longitude	
				Start	End
Item	2015 USACE Erosion Survey, DRAFT			38.224850 °	38.223233 °
				-121.555641 °	-121.555687 °
DWR ID	DWR_RD0556_02_s_2016_10				
Comment Code					
Inspector Comment					
2000 - Recently fallen cottonwood at the downstream end. 2005 - Empty brush boxes. 2011 - A few trees have fallen since last year. 2012 - Potential new tree popout since last year. 2013 - New erosion at downstream end of site and a recent tree pop-out observed. 2015: No observed changes. [2015 Site ID: SAC_23-2_L]

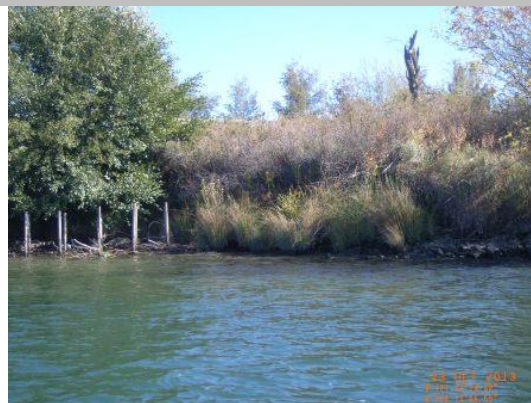
Photo 1 of 1 : SP_2016_RD0556_19_8_20160223_00007.jpg

LM Start	3.58	Rating **	M	Issue No.	8
LM End	3.64	Issue Type +	Ma	Location *	WS
Category	Supplemental			GPS Latitude/Longitude	
				Start	End
Item	2015 USACE Erosion Survey, DRAFT			38.218951 °	38.218104 °
				-121.556689 °	-121.556819 °
DWR ID	DWR_RD0556_02_s_2016_8				
Comment Code					
Inspector Comment					
1997 - Scallops into berm and very close to levee toe. 2005 - Brush boxes present. 2011 - New toe scour and freshly fallen tree. 2012 - New tree popout has taken significant portion of soil out of the levee. 2015: No observed changes. [2015 Site ID: SAC_22-7_L]

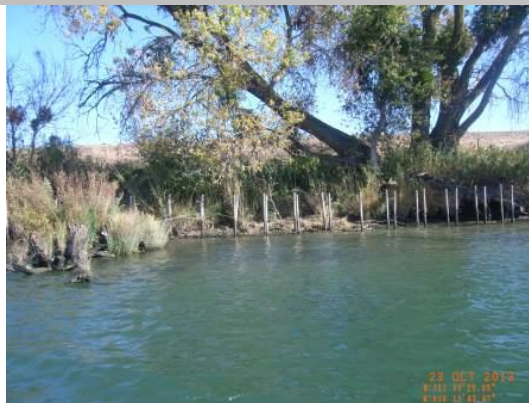
Photo 1 of 1 : SP_2016_RD0556_19_4_20160223_00004.jpg

LM Start	3.95	Rating **	M	Issue No.	4
LM End	4.12	Issue Type +	Ma	Location *	WS
Category	Supplemental			GPS Latitude/Longitude	
				Start	End
Item	2015 USACE Erosion Survey, DRAFT			38.213581 °	38.211112 °
				-121.557197 °	-121.557042 °
DWR ID	DWR_RD0556_02_s _ 2016_4				
Comment Code					
Inspector Comment					
2002 - Spot rock along berm, but not in the erosion pockets. 2005 - Some new minor stone revetment at the upstream end. Brush boxes present. 2006 - Currently installing new brush in downstream brush boxes. 2007 - Rock in middle portion for about 150 ft. 2010 - Some attempt at repairs but still has pockets of erosion. 2012 - More erosion along the toe. 2015: No observed changes. [2015 Site ID: SAC_22-5_L]

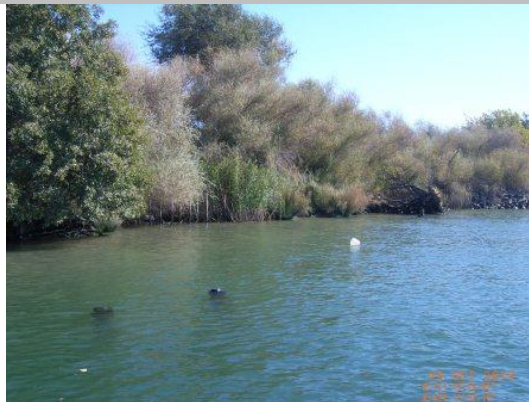
Photo 1 of 1 : SP_2016_RD0556_19_7_20160223_00006.jpg

LM Start	4.45	Rating **	M	Issue No.	7
LM End	4.49	Issue Type +	Ma	Location *	WS
Category	Supplemental			GPS Latitude/Longitude	
				Start	End
Item	2015 USACE Erosion Survey, DRAFT			38.206377 °	38.205729 °
				-121.557184 °	-121.557108 °
DWR ID	DWR_RD0556_02_s _ 2016_7				
Comment Code					
Inspector Comment					
2013 - Erosion pockets encroaching on levee foundation. 2015: No observed changes. [2015 Site ID: SAC_21-9_L]

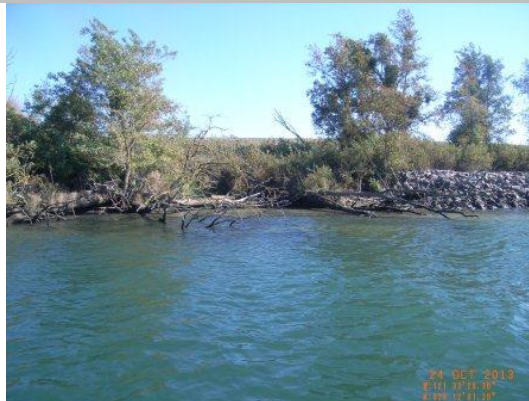
Photo 1 of 1 : SP_2016_RD0556_19_3_20160223_00003.jpg

LM Start	4.77	Rating **	M	Issue No.	3
LM End	4.88	Issue Type +	Ma	Location *	WS
Category	Supplemental			GPS Latitude/Longitude	
				Start	End
Item	2015 USACE Erosion Survey, DRAFT			38.201687 °	38.200225 °
				-121.557305 °	-121.557749 °
DWR ID	DWR_RD0556_02_s_2016_3				
Comment Code					
Inspector Comment					
1999 - Downstream 140 ft repaired with rock. 2010 - Lots of woody debris, but no changes to site. 2015: Site extended upstream due to erosion pockets. [2015 Site ID: SAC_21-5_L]
